# RESEARCH AND INVESTIGATION INTO THE PERFORMANCE OF RESIDENTIAL BOUNDARY FENCING IN BUSHFIRES

The research investigated the effects of typical Australian bushfire exposures on residential boundary fencing systems manufactured from prepainted and metallic coated sheet steel, treated softwood (pine) timber and hardwood timber.

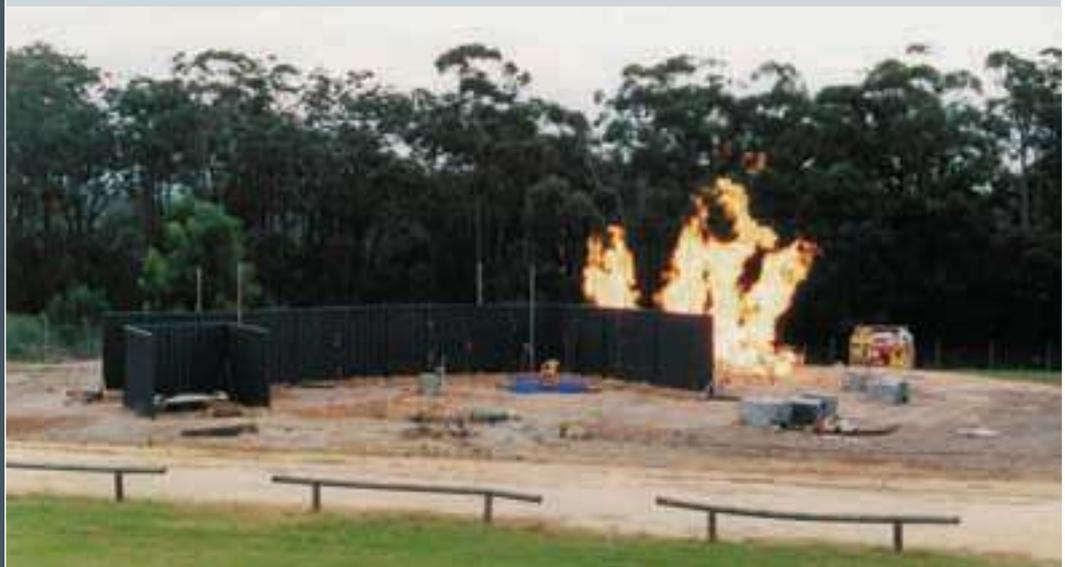
NSW RURAL FIRE SERVICE EXPERIMENTAL TESTING SITE AT MOGO.
